TRANSPORTATION SAFETY

REFLEXIONS

Issue 20 – March 2003

M A R I N E

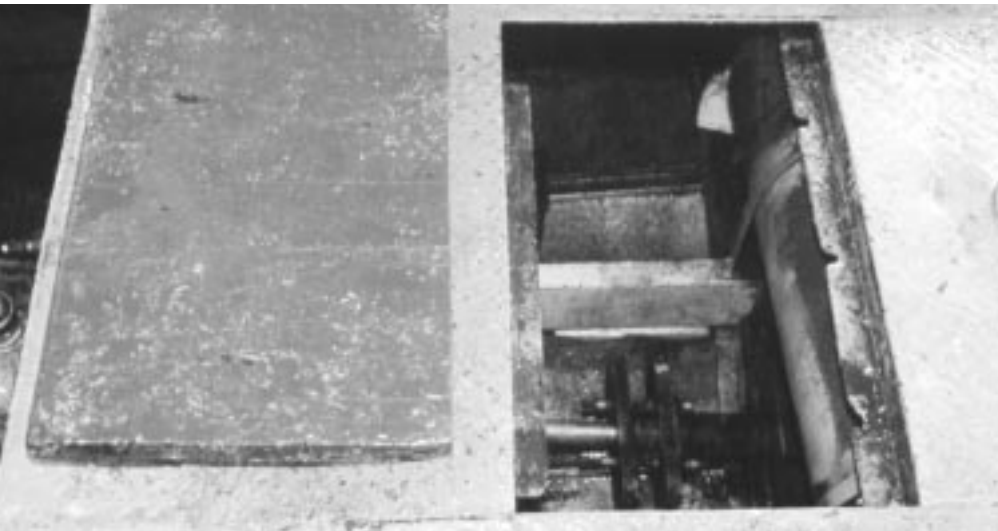
Hatch opening in main deck with no sealing gasket or means of securing flush wooden cover.

From the time of her entry into service as a passenger vessel in 1972 until 2000, the *True North II* was inspected annually to ensure compliance with *Hull Construction Regulations, Life Saving Equipment (LSE)* [Regulations] and other regulatory requirements. Throughout this 28-year period, various modifications and additions to the structure, propelling machinery and safety equipment were inspected and accepted by regulatory inspectors. In its investigation of this accident, the Board found that modifications to the vessel had compromised its watertight integrity.

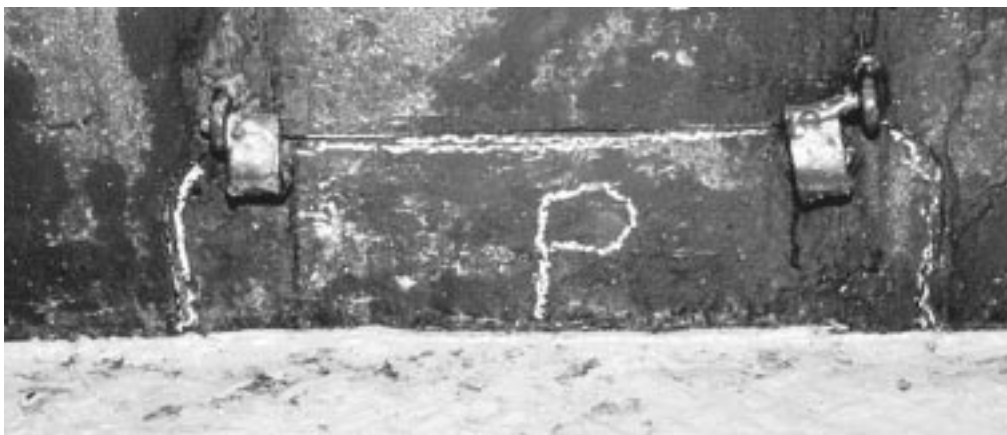
Main deck freeing port welded shut. Starboard side is similar.

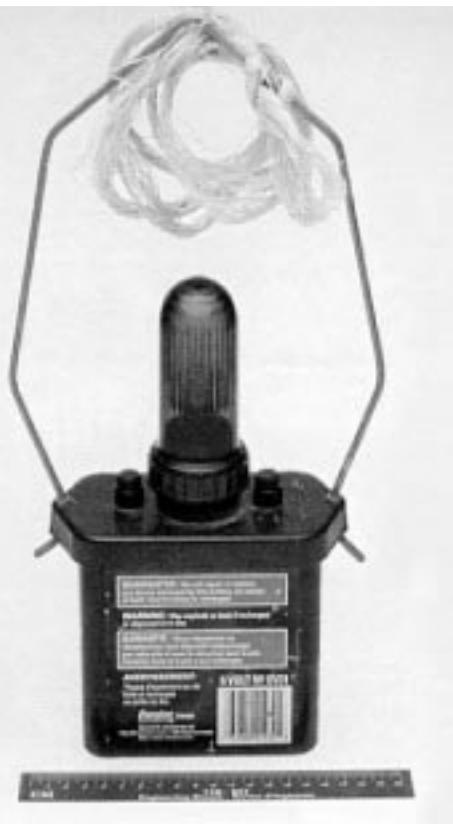
during a nighttime passage, the master noticed that the barge's starboard sidelight was flickering. On August 7, when the barge was prepared for the passage, the deckhand positioned and secured a temporary *Scotty* lantern that had been improvised for use as a portable starboard sidelight. In a test subsequent to the accident, the lantern with a green (starboard) lens was found to have a maximum visibility range of less than four cables (0.4 nm). International regulations required the sidelight to have a minimum visibility range of three nautical miles. At the time of departure and later en route, the master observed the green sidelight of the barge approximately 300 m astern of the tug.

The lantern that had been aboard the *Texada B.C.*

- TC is working with industry to develop portable navigation lights that meet COLREGS.
- The *Festival of Fire* developed a search-and-rescue plan, which includes escort vessels to assist in separating commercial and pleasure craft.
- Vancouver MCTS made changes to its operations for special events in the harbour.
- The Canadian Coast Guard contemplated changes to the *Boating Safety Course* syllabus to include information on COLREGS.
